Bartlett History Museum

Progress Report

September 2020

Our Building's New Roof Signals the Completion of Renovation Phase 1!

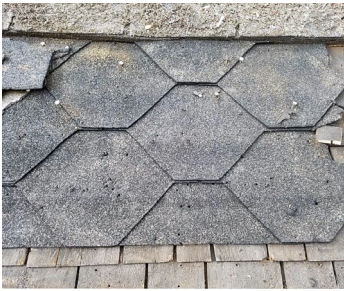
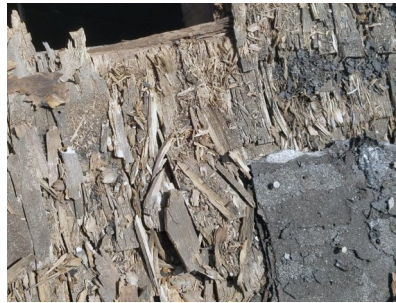
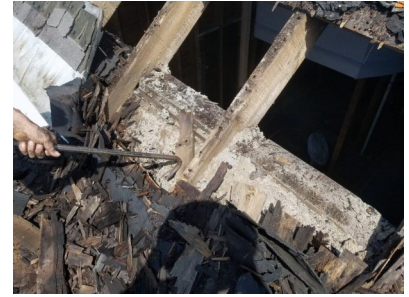
From the architects report and Bill's assessment, we learned that the roof rafters were undersized from the day the building was built. The collar ties that hold the rafters from spreading were placed too high in the frame thus decreasing their effectiveness. After many years of excessive weight on the frame due, in large part, to five layers of asphalt shingles plus a layer of wood shingles and sheathing boards, the rafters were "deflected" or bowing inward. It was estimated that the asphalt shingles were pressing down with about 25,000 pounds of weight on the building. The roof was also leaking very badly and even with tarpaulins on it, water still infiltrated. The long walls of the building were bowing outward by as much as 5" - 7" on each side of the building. Bill estimated that we were at a dangerous point with the structure and it was nearing the point of collapse. The roof project that you, our donors, funded changed all of that and we now have a safe, secure, dry building. Bill's comment to Phil Franklin was that the building is now square to an eighth of an inch. The best way to tell this story is in photographs so let's turn the page and see the story.

Above—Left first course of asphalt shingles found covering original wood shakes; Center & Right above, shows close-up shots of the south side roof deterioration. Most of this lower part of the roof was removed by hand and fell apart as it was touched

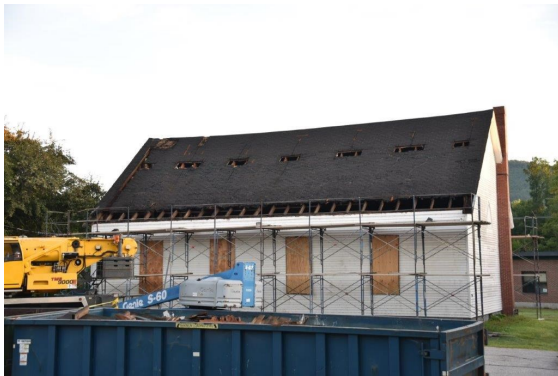
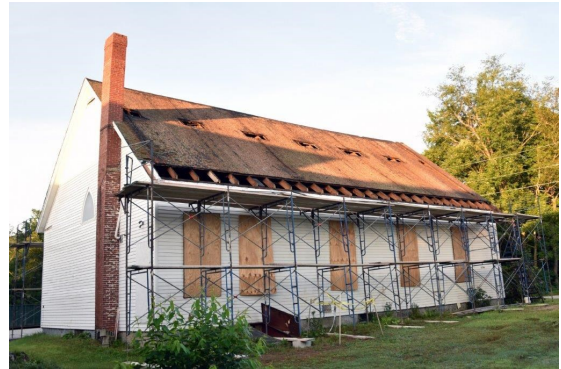
Above—Left, the south face of the building prepared for removal of the roof; Right is the north face of the building.

The color differences in the two roofs reflect a heavy moss covering on the north face while the south face is free of moss. The holes in the roof are in place to allow the cables from the crane to be connected to the roof sections during the removal process. The lower section of the roof frame was exposed to allow the rafters to be cut for the roof removal. Windows are boarded to protect the original stained glass windows on the building.

Also, notice the curve in the chimney in the right photo; its been that way for decades; it's not a photo illusion. We'll have more on the fate of the chimney in layer photos.

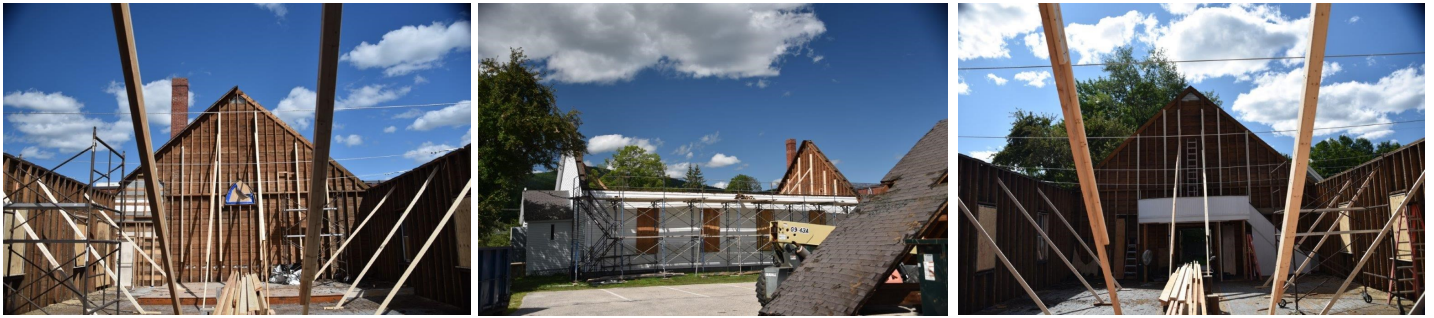
Left photo shows gable peak/end of the building where the altar was located; bracing holding the walls in place

Center photo shows the building from the bend on School Street;

Right photo shows a view back to the choir loft with the gable of the front of the museum building. Both gable ends as well as the long eave walls of the building were straightened in the rebuilding process

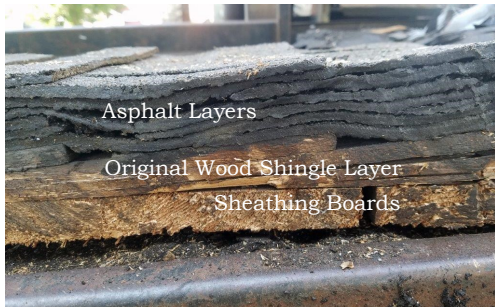
Detail Views

Left—Cross section of the roof showing asphalt shingles over the original wood shingles over the sheathing

Right—View down the top of the south wall showing the bow in the wall that was even worse when the roof was pressing on it

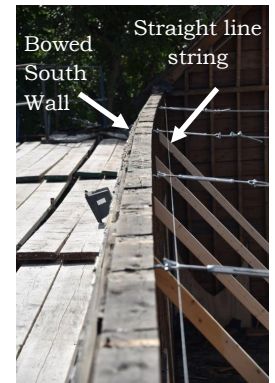
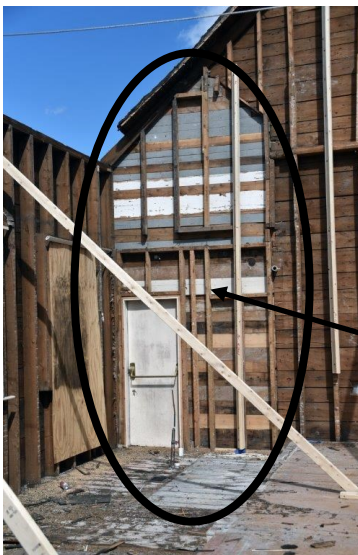
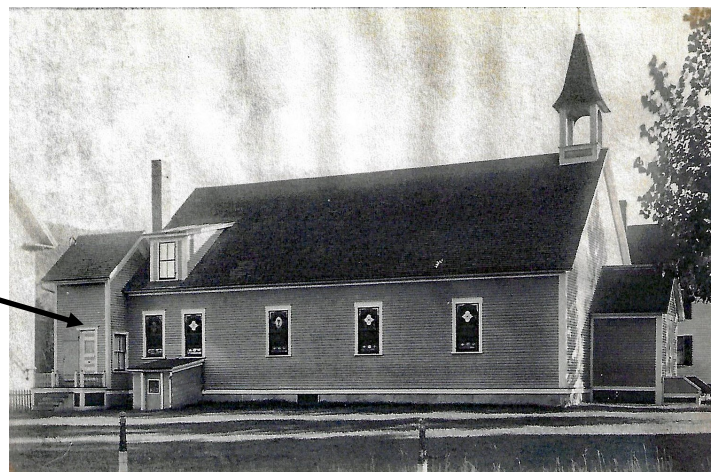
Left—Photo shows patchwork siding installed when priest's apartment section of the building was removed (removal date unknown);

Right—Arrow points to location of priest's apartment section on the original church

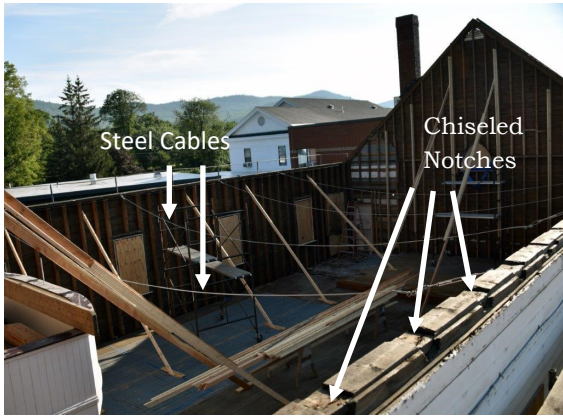
Temporary cables installed November 2019 to hold building together once taugh, now sagging after roof removal

Also, notice notches in the top plate on the long wall; original builders chiseled custom notches for each rafter to level them to the building

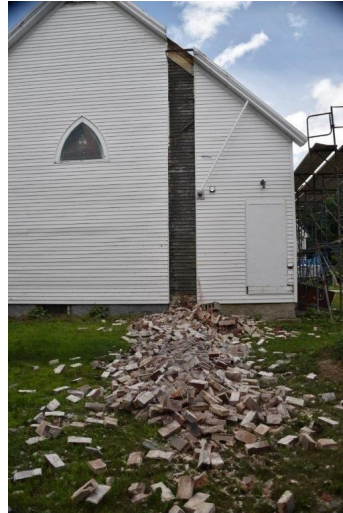
Chimney Collapse—An inspection of the chimney revealed a need for significant repair. While taking the top of the chimney down, it suddenly leaned away from the building and then collapsed. No one was injured in this fall. We are not planning to replace the chimney as it will not be needed for museum heating.

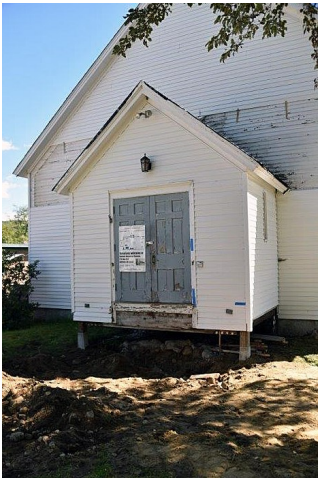
After completing the roof, the next step in the process and the start of our Phase 2 work to get the building open was the project to level the front foyer area and replace the front steps and sidewalk. In the process of doing this work, Bill Duggan discovered that the front two corners of the foyer were resting on the ground, not on stone to concrete piers as would be expected. That explains why the foyer was leaning to the south. Bill also discovered another five layers of shingles on the foyer roof. Fortunately, the sheathing boards were in good shape and could be reused.

View of the front of the building, foyer level, stairs and walkway removed

As we write this newsletter, the foyer portion of the building is now level with concrete piers supporting it, the roof has been replaced and the front steps and walk have been removed. We are replacing the front steps with granite steps. The sidewalk will be concrete but we are raising the level of the walk (the old one was sinking into the ground) so the new walk will pitch to the road, thereby shedding water appropriately. We will also bring in loam to pitch the land away from the front of the building and walkway. Below are some photos of our work in progress on this portion of the building.
