Bartlett History Museum Progress Report Newsletter Supplement

January 2020

Future Bartlett History Museum
Today

The Purchase of the Building

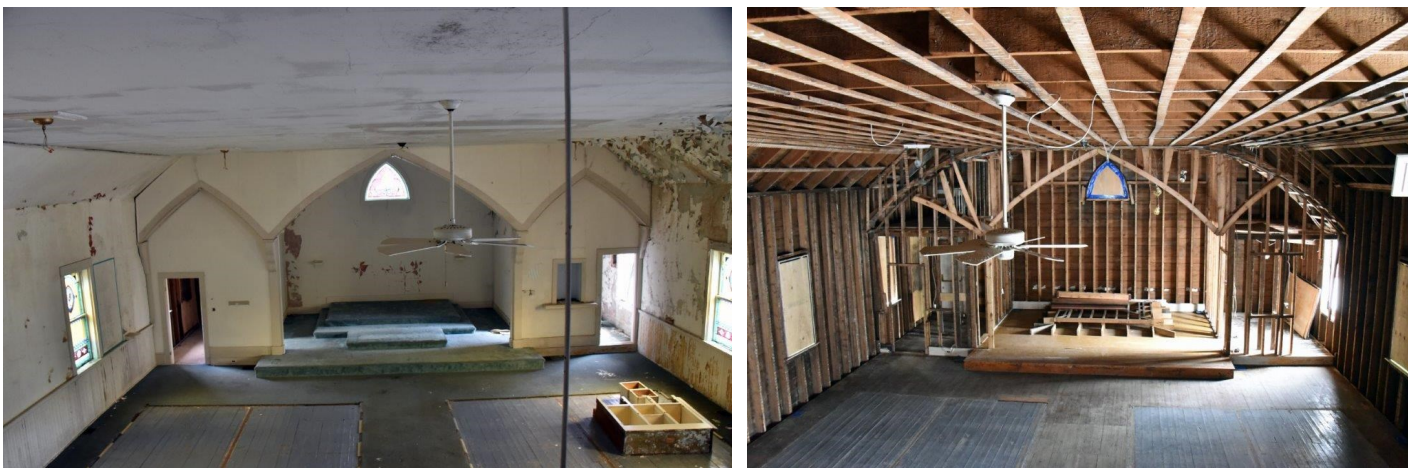
View of the front altar area from the choir loft, before demolition (l); after demolition (r)

Notice the single arch frame in the right hand photo and the wood that framed the three arches hanging off the single arch—the single arch was the original configuration of the church. We will preserve that single arch in our museum.

The sacristy was to the right of the altar; a passage to the back exit was to the left.

After Acadia completed their work, the building smells like fresh wood, the frame is exposed and we have a clean, safe building. Even the basement has been cleaned. We found some surprises when the walls were opened. We found the priest's apartment, three window frames that were covered over, a hatchway that was likely the original access to the basement and a "No Parking" sign that one of our prankster forefathers tucked into a bay between two studs. We've included some before and after photos to show the difference between September and now. We were very pleased with the work done by Acadia.

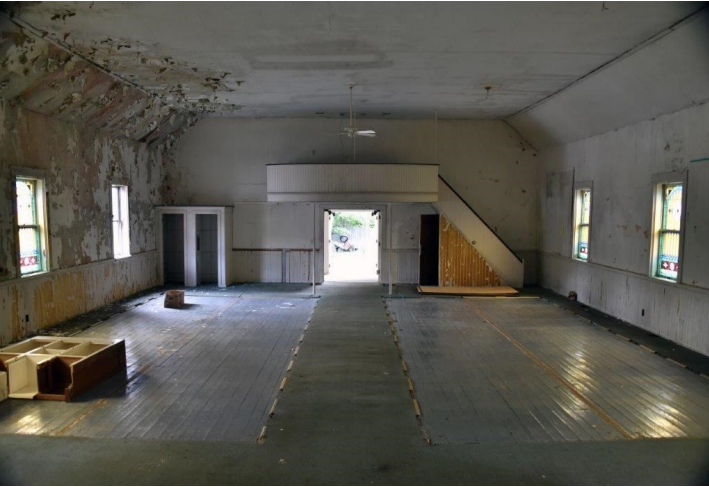
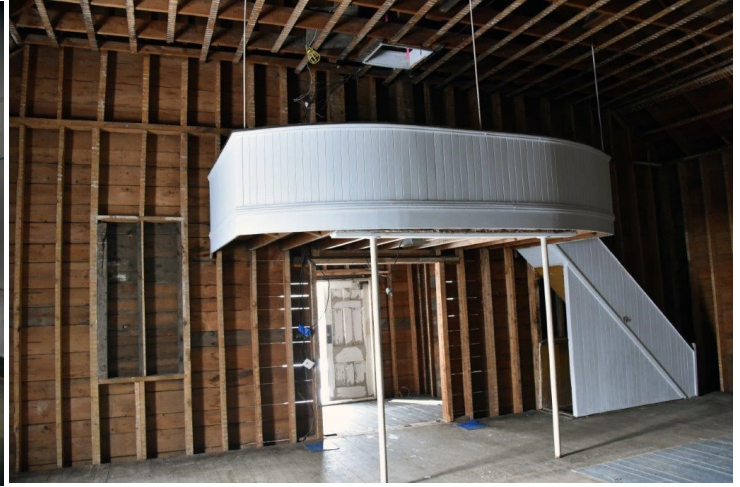
View of the church entry from the altar on the left and a slightly different angle on the right. We are planning to keep the choir loft in place. We needed to remove the confessional during the demolition. Notice the window frame that was covered in the wall in post demolition photo. There's an identical one frame behind the stairway to the choir loft. It's not known when they were covered.

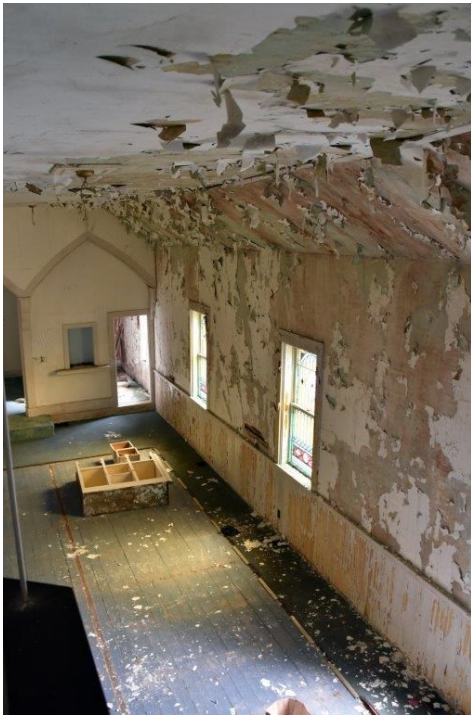
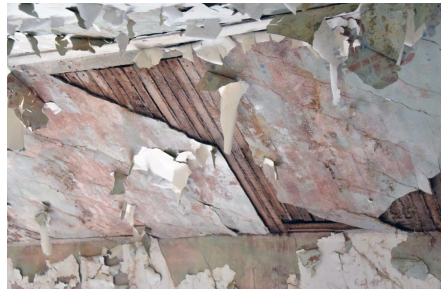
View of the south side wall and ceiling (right side of church) showing heavy water damage in the photo above and on the left; above photo shows area where plaster fell from ceiling; left shows peeling paint and deteriorating plaster.

Before Acadia started work, the first thing that hit you when you walked into the foyer was the strong smell of mold. Then, people noticed the floor seemed a bit soft. Actually the base floor was hard as a rock but the plywood under the carpeting had delaminated giving the Disney-like illusion that the floor was rotten and you were falling into the basement. Inside the building, paint was peeling everywhere, sections of plaster were falling without assistance, mold graced the walls and, after a rain storm, there was water on the floor as our roof is quite porous.

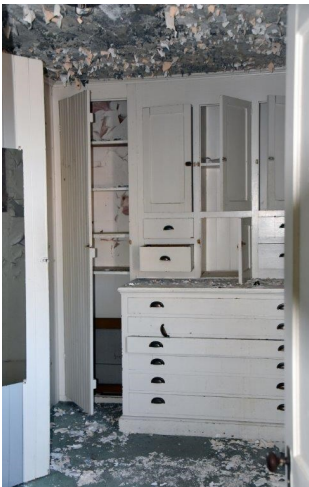
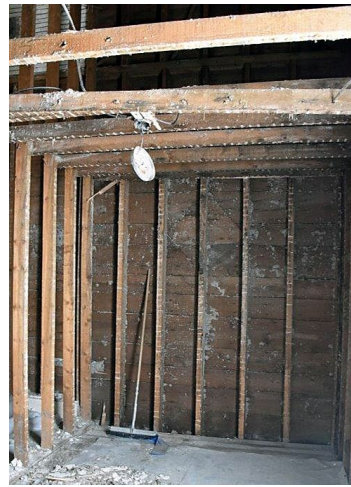
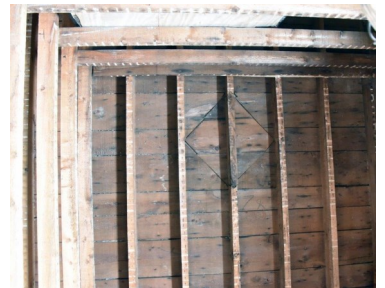
View of Sacristy (l two), ceiling covered in mold, the lower cabinet was saved. Sacristy during cleaning (r); the diamond on the wall was once a window that was closed and covered over
