Bartlett History Museum

Progress Report

September 2020

Our Building's New Roof Signals the Completion of Renovation Phase 1!

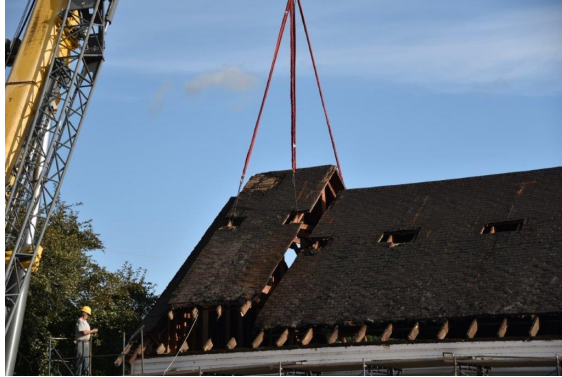
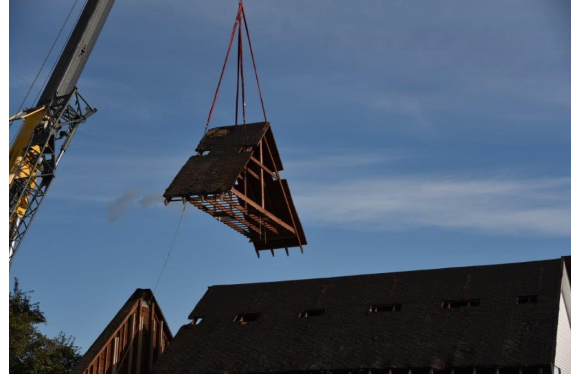
The first section of the building is lifted off the building and airborne

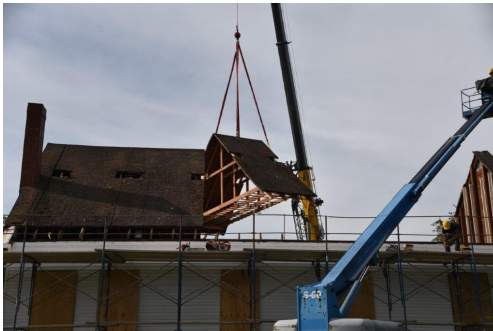
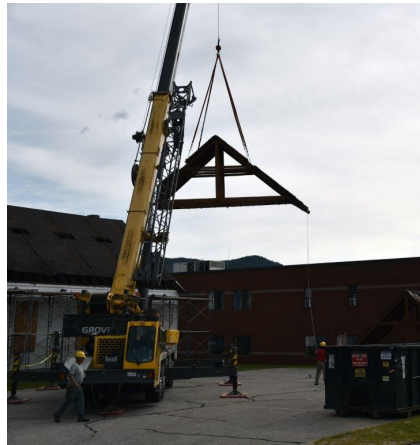
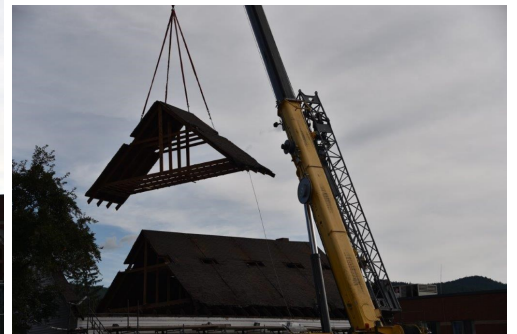
More roof sections are removed from the building

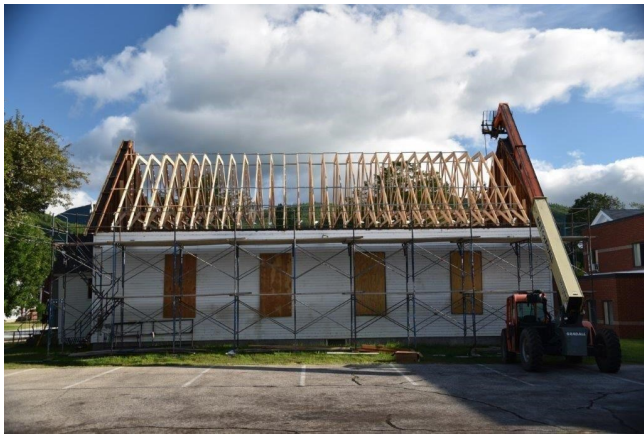
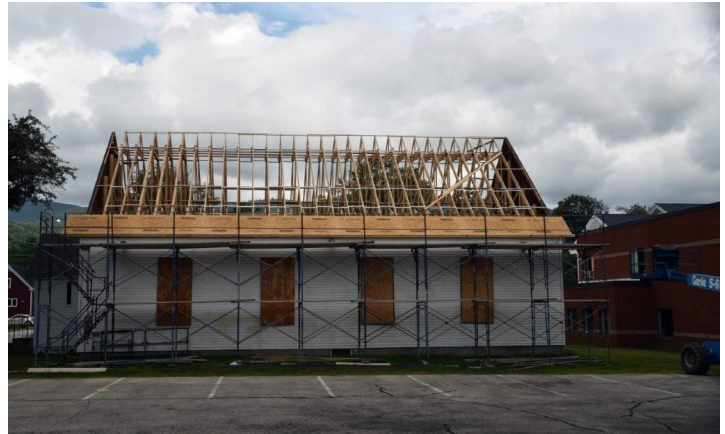
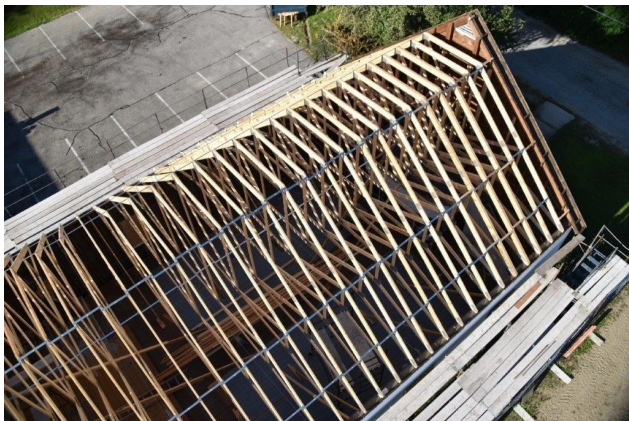
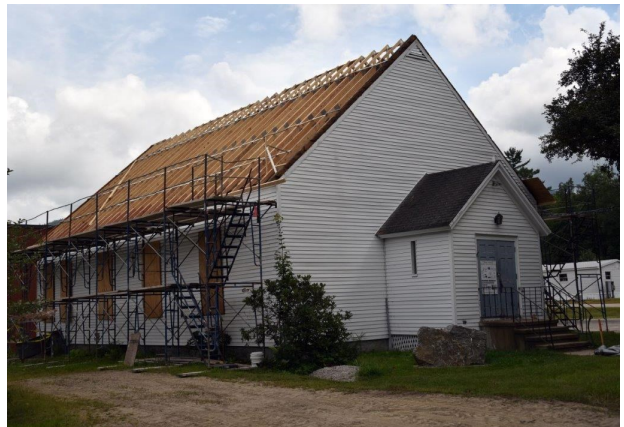
Roof Truss Installation

Top Left—the last truss is positioned; Top Right—Trusses are complete with top peak installed
Bottom Left—View of trusses from above with peaks for each truss to be installed
Bottom Right—View of building from School Street with truss work complete

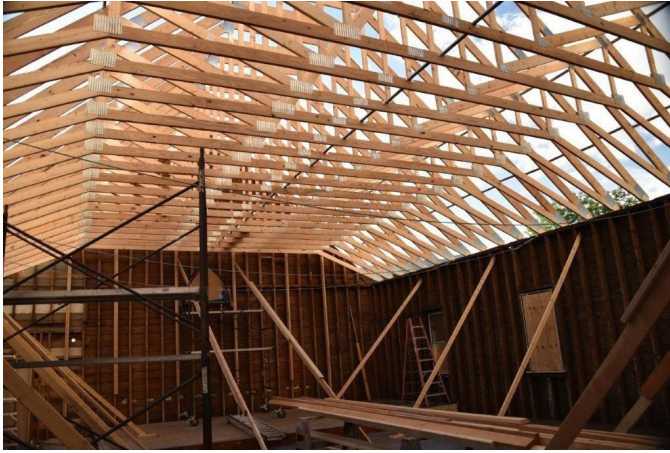
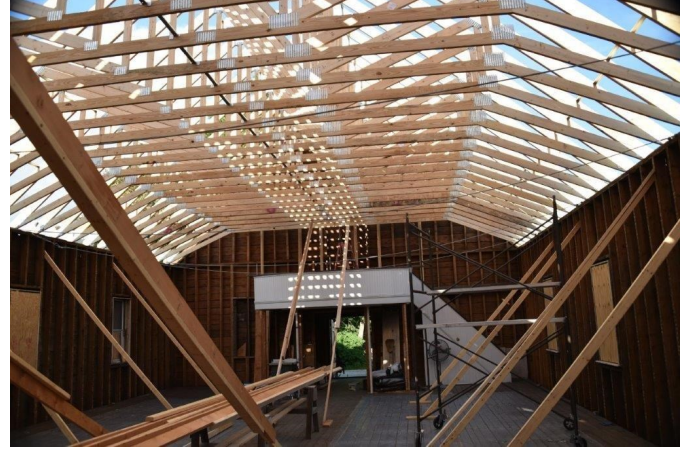
Interior views of the trusses. Note that we kept the same ceiling design as in the original roof with sloped sides and a flat center ceiling

Left—View looking toward where the altar was formerly located

Right—Looking to the choir loft

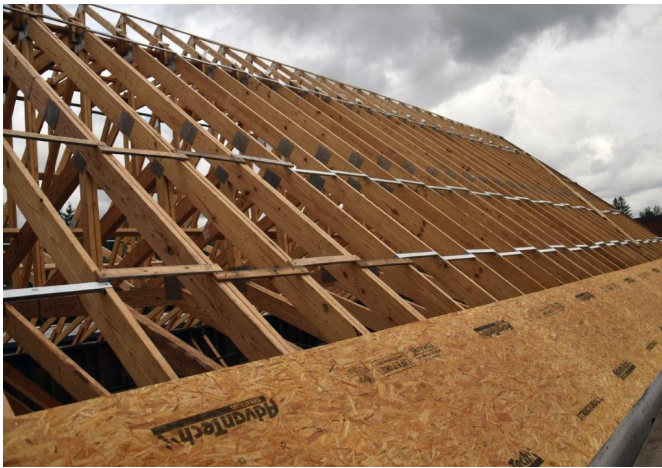
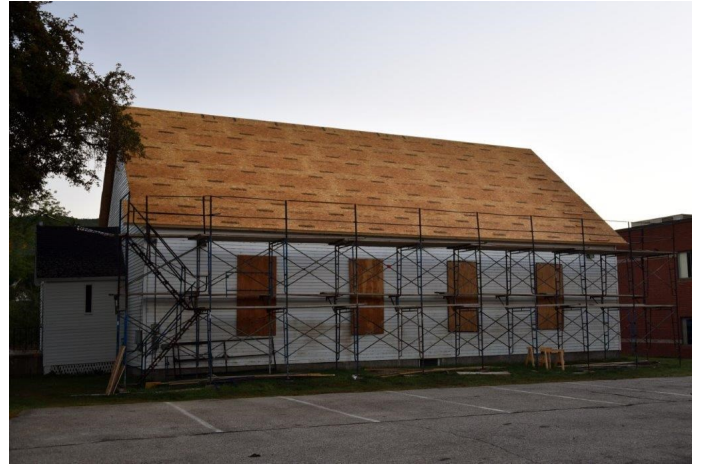
Sheathing installation in progress and complete

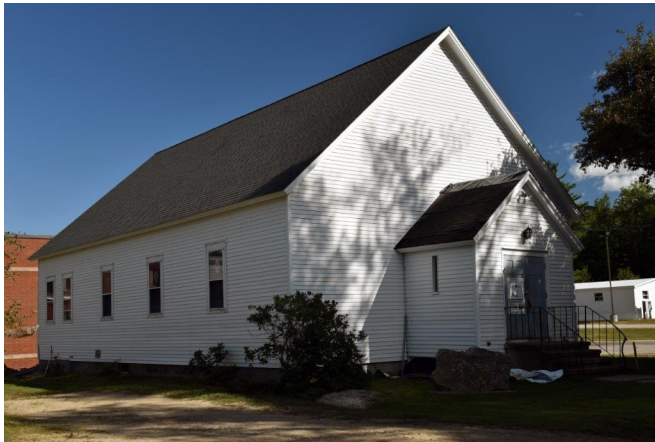
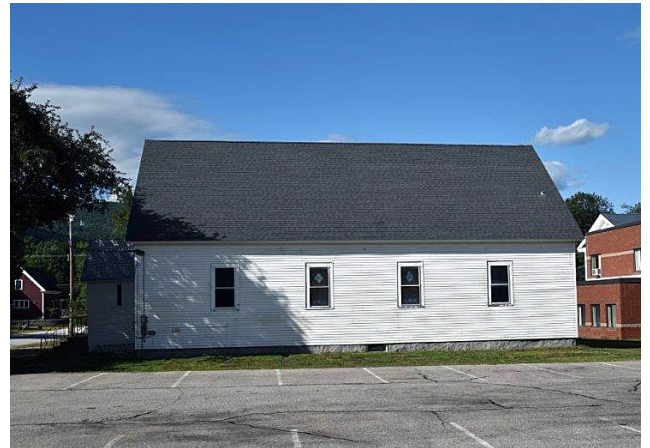
Roof installation is complete!

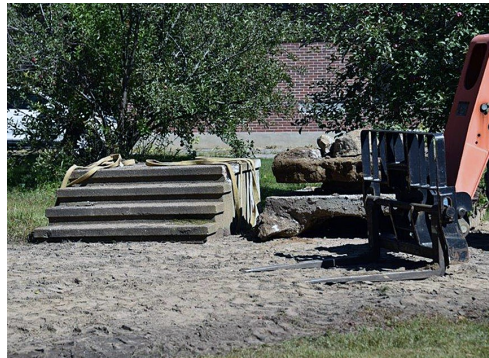
Concrete precast stairs set aside waiting to be disposed of; we know they were installed prior to 1955 based on dated photographs but we don't have an exact installation date; the original steps for the church were wooden
